An Investigation into the Death
of a Nuclear Safeguards Inspector
Vienna, Austria, February 1978

John E. Foley, Ph.D.
jefethics@aol.com
541-490-3062
May 2022

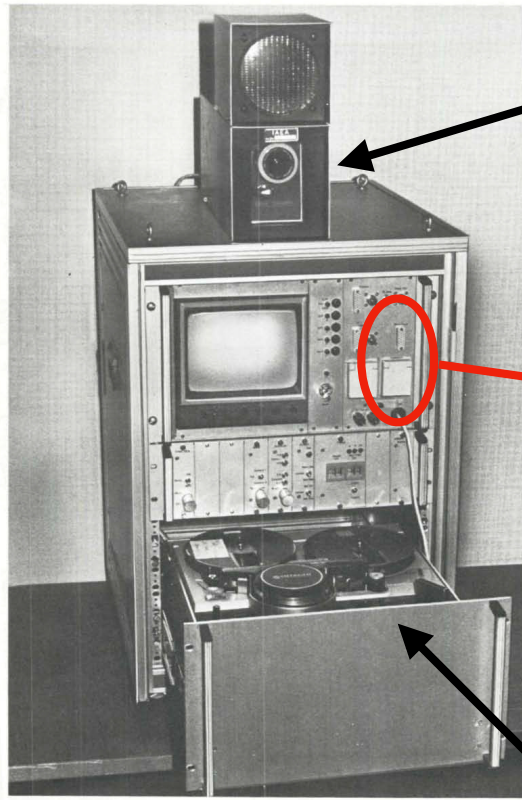
**Fig. 1. IAEA CCTV control unit, circa 1977. (Photo
from *IAEA Bulletin*, vol. 19, No. 5, October, 1977.)**

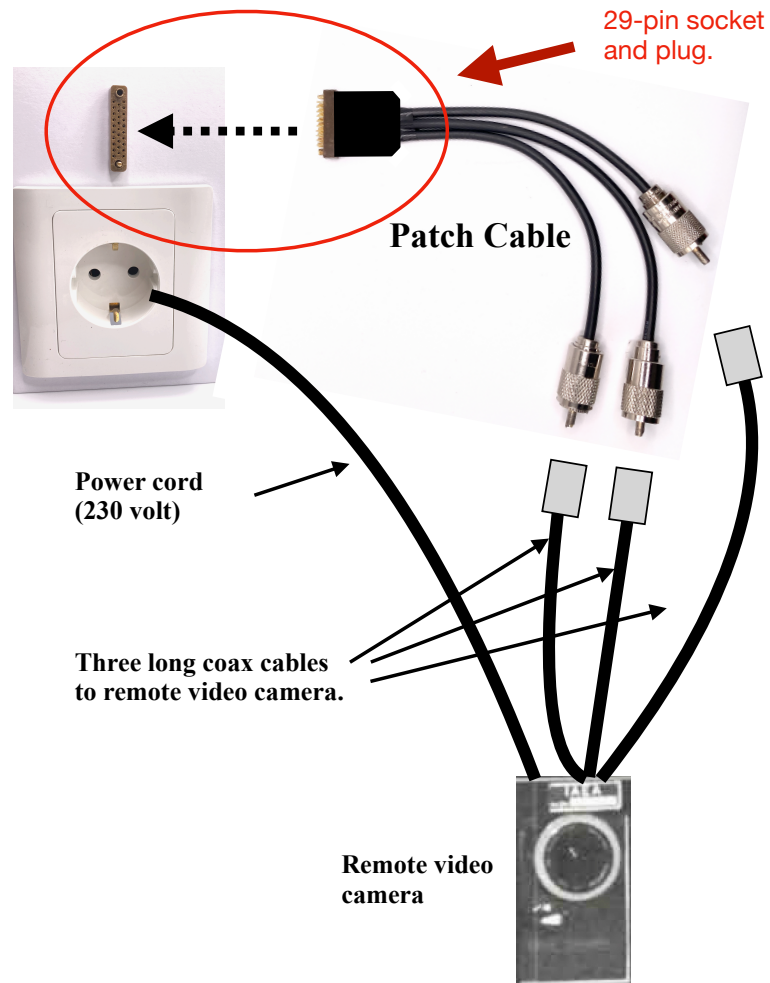
The three long coax cables running to the video camera are for the analog video signals and horizontal and vertical synchronization (sync) pulses. These coax cables plug into the 29-pin socket on the control unit via a “patch cable,” which consists of three short (12”-18”) coax cables with a matching 29-pin plug at one end and three coax connectors on the other (Figs. 2, 3).

Fig. 2. Power and video connections to remote camera. The 29-pin socket and matching plug on the patch cable (highlighted above) are important in this investigation.

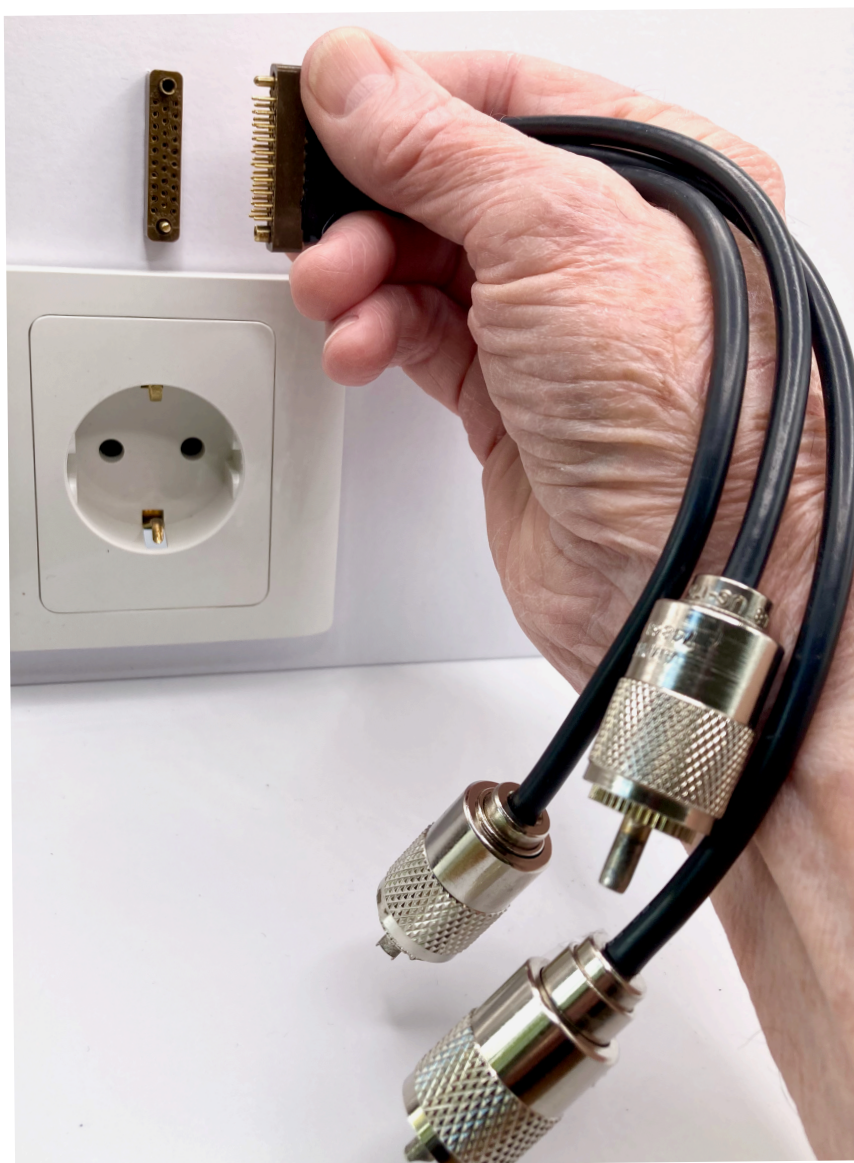
This patch cable and the matching 29-pin socket on the control unit proved to be important in the investigation into Noir’s death. To illustrate what the patch cable looked like, I’ve made a replica of it (Fig. 3). The 29-pin plug and matching socket in the photo are vintage connectors I purchased on the Internet, and they are nearly identical in shape and size to the actual ones. (Note: I made the coax cables of this replica shorter than the actual ones (12”-18” long) so they would fit into the photograph.)

Fig. 3. Replica of patch cable and 29-pin socket on control unit.

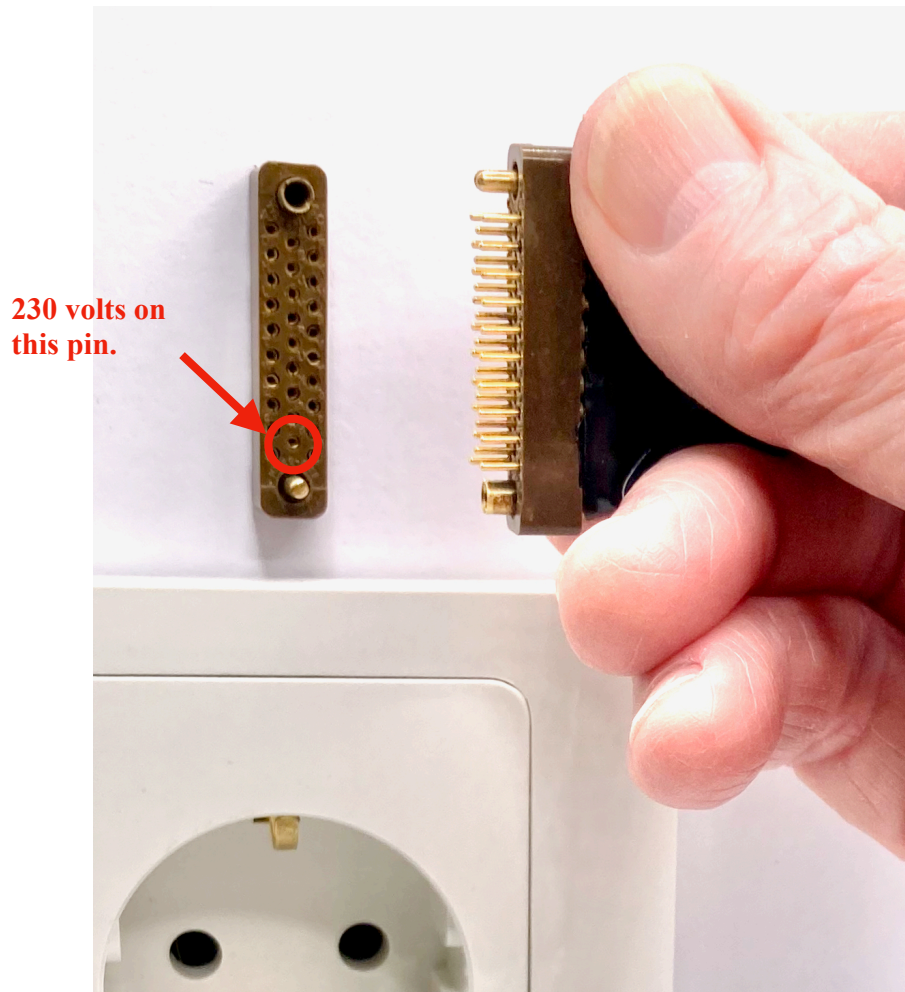
Because I found nothing suspicious with the wiring associated with the 230-volt power plug, I had to trace “deeper” into the control unit. After a couple of days, I noticed a high-voltage wire (230 volt), mostly hidden from view behind other components, *that connected to a pin on the 29-pin video socket*. And, with a voltmeter, I verified there was 230 volts on the *bottom pin of the middle column of pins* of this socket (Fig. 4), which meant this pin was electrically “hot.” And this was true for all the CCTV units that I was testing in my TV lab. In fact, this wire was built into the design.

This “hot pin” was the first sign of possible trouble. This socket is for low-voltage video and sync signals, not electrical power. Why would it be wired for 230 volts, especially when 230 volts was already supplied to the video cameras via the European power sockets?

Fig. 4. Close-up view of the 29-pin socket and matching plug on the patch cable (replica). Surprisingly, 230 volts was measured on the bottom pin, middle column of pins.

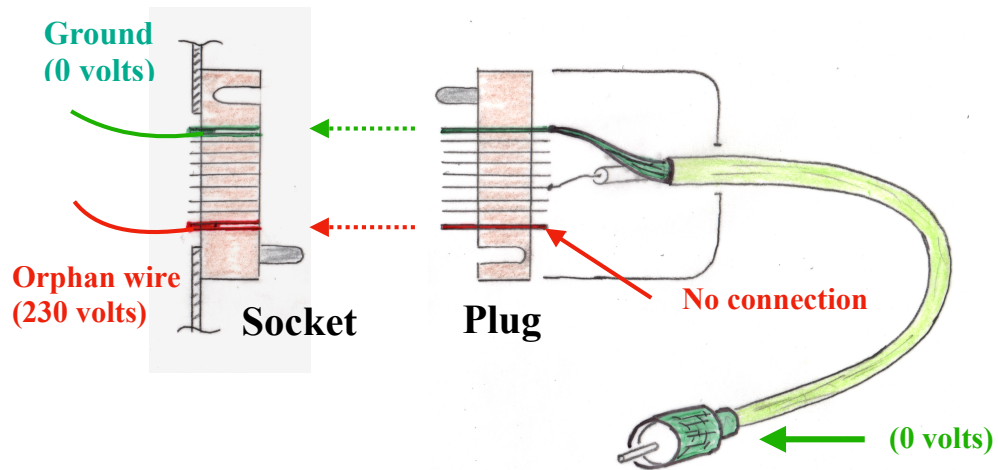
To try to understand what this 230-volt wire was for, I disassembled a patch cable and examined the pin that this wire would connect with. Fig. 5 is an “X-ray” sketch of the *middle column of pins* of the plug (and socket).⁵ In this sketch and other sketches, I’ve identified the high voltage (230 volts) by the color **red**, and ground potential (0 volts) by **green**.

The bottom pin of the plug connected with the “hot” 230-volt pin of the socket (Fig. 5)—but, oddly, there was nothing connected to this pin! Instead, the “hot” wire dead-ended at the plug.

Also, notice that in Fig. 5—and this turns out to be very important—the top pin of the plug connects to ground (0 volts). Thus, the shield of the coax cable and the coax connector are at ground potential (0 volts). (The center wire of the coax cable plays no role in this investigation.)

Fig. 5. Sketch of wiring of socket on control unit and plug on patch cable. Middle column of pins.

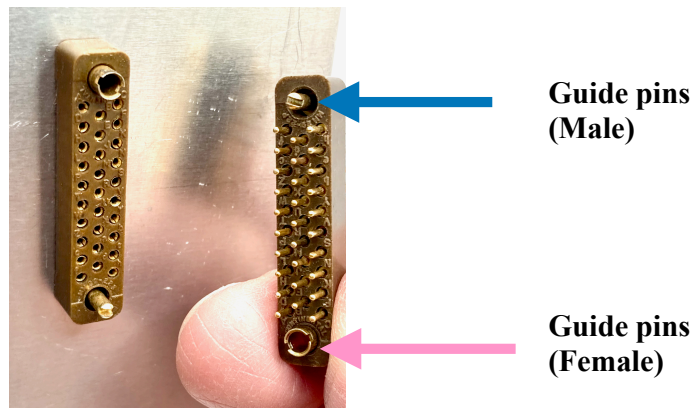
- First, the pins of the plug, as well as pins of the matching socket on the control unit, were arranged symmetrically, both left and right, top and bottom (Fig. 6).
- Second, the large male and female guide pins, at the top and bottom of the plug, were *removable and could be interchanged* (Fig. 7). The purpose of the guide pins was to ensure the plug was inserted into the socket correctly.

Fig. 6. Guide pins and symmetrical pattern of pins on socket and plug (right/left, top/bottom).

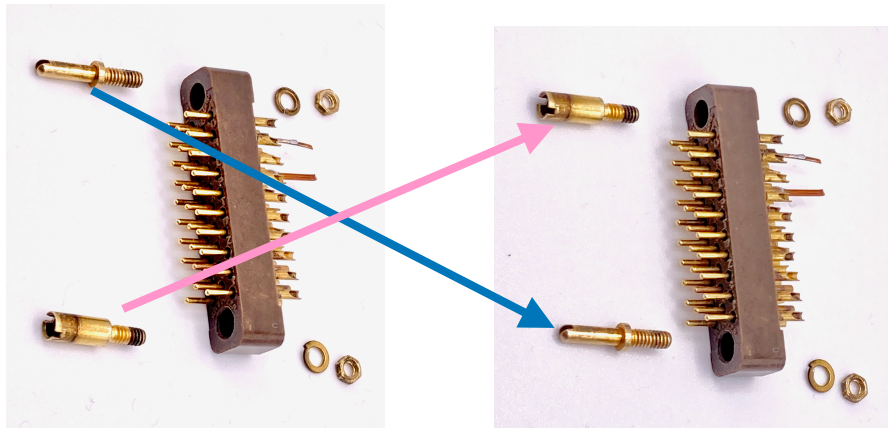
Eureka! I immediately realized the terrible significance of this configuration: if the guide pins of the plug were switched, then the patch cable could still be inserted into the socket on the control unit if the plug is turned upside down. If that were to occur, then the pin that had been at the top

Fig. 7. Incorrectly assembled plug on patch cable. Guide pins switched by mistake. The plug will still fit into the socket on control panel if it is turned upside down.

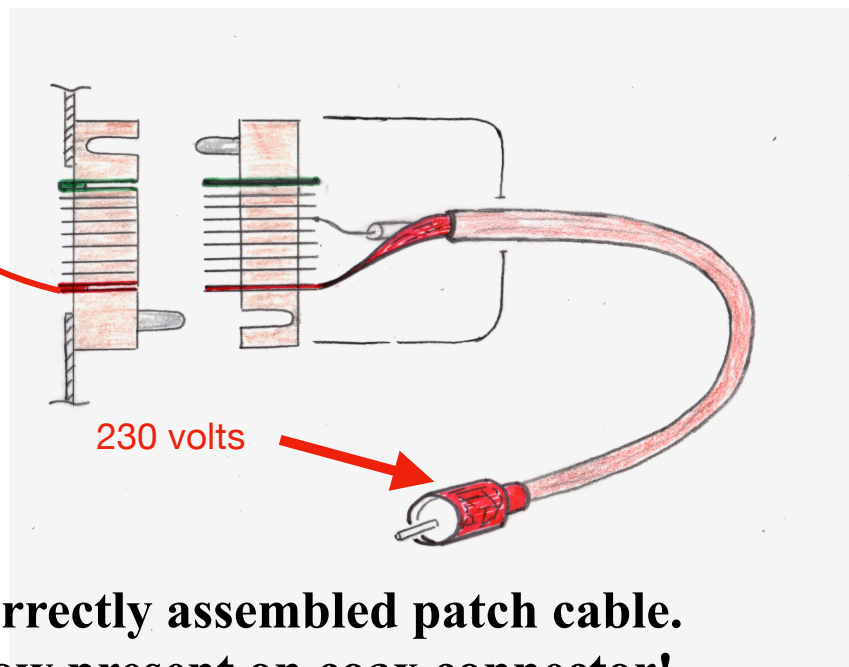
of the plug would now be at the bottom (Fig. 8). This pin would now connect to the “hot” orphan wire and the coax connector of the patch cable would be “hot,” 230 volts (Figs. 8, 9).

Fig. 8. Incorrectly assembled patch cable. 230 volts now present on coax connector!

Kerr and I decided the safest—and quickest—thing to do was to cut/remove the orphan wires inside the control units. This would eliminate the hazard. I developed instructions for inspectors on how to safely cut the orphan wires, and I also trained several of them how to do it using the CCTV units in my lab. I personally made a quick trip to the Pickering Nuclear Station in Canada to cut the orphan wires in two CCTV units (a total of four video cameras) that were being used in an important verification exercise of fuel transfer in CANDU reactors.

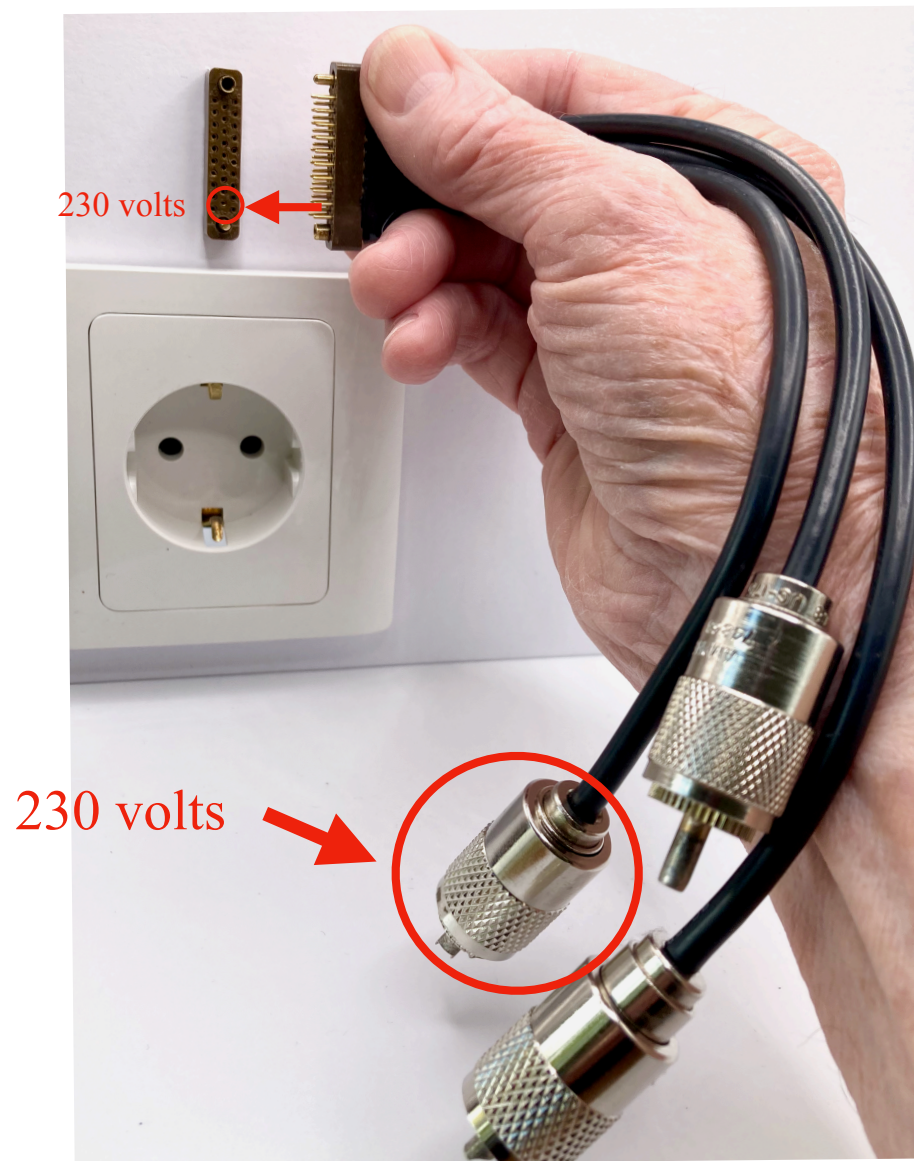
Les Thorne (England), who was Noir’s boss, traveled to Taiwan immediately on hearing of his death. He returned to Vienna a few days later with the actual patch cable that Noir was working with. I examined it and verified that *it was assembled incorrectly*—the guide pins were switched, and there was a direct electrical connection between the bottom pin, middle row, of the plug and the coax connector (Figs. 8, 9,10).

Fig. 9. Incorrectly assembled patch cable. Guide pins interchanged. 230 volts on one of the coax connectors.

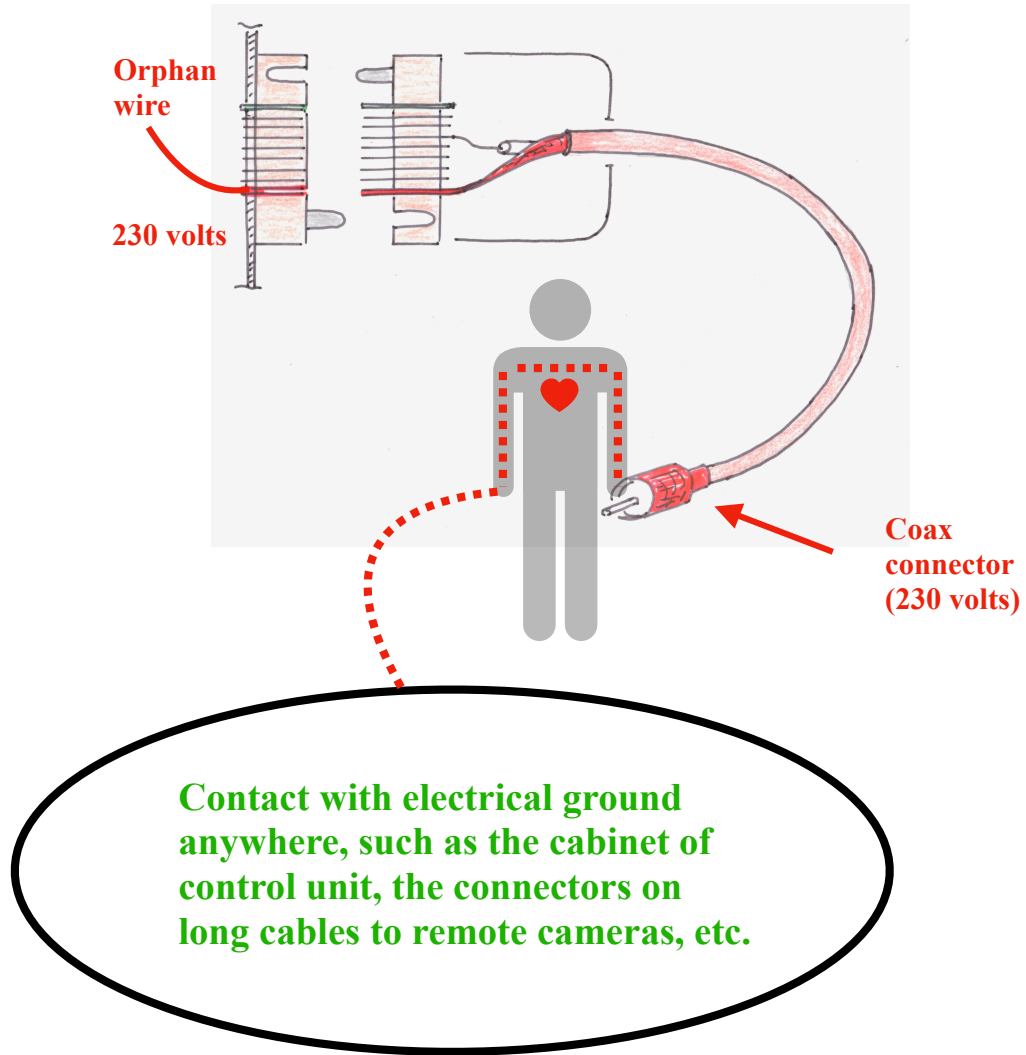
I informed my boss, Ed Kerr, about this serious problem with the patch cable and the danger to anyone handling it (Fig. 10). Our immediate concern was for the safety of our inspectors. There were 20 or so CCTV systems in various stages of implementation and operation at nuclear facilities around the world, and they all had the “hot” orphan wires.

I now had my answer to Barda’s question: “Yes, Pierre could have been electrocuted. And, he probably was.” The evidence strongly suggests that this tragic accident happened because of two specific problems:

- The “hot” orphan wire
- the incorrectly assembled plug of the patch cable

Both problems had to be present for the accident to occur. If there was no orphan wire, the accident wouldn’t have happened, and if the plug had been assembled correctly, the accident wouldn’t have happened. But *both* of these problems were present when Noir was working with the CCTV system in Taiwan, and in my investigation, I was able to identify clear evidence of this.

Fig. 10. Electrocution accident. Incorrectly assembled plug on patch cable.

Some inspectors lost all confidence in the CCTV units and had them shipped back to Vienna. It was my understanding that all the CCTV units would eventually be returned to Vienna to be updated by Psychotronic Elektronische Geräte with a new front panel that replaced the 29-pin video sockets with standard female coax sockets, which eliminated the need for patch cables.
